Rex's Speed Shop
Guide Y-10: CDI Ignition Generator Checks Troubleshooting
 Yamaha RXS100 1983 ~

Testing the CDI generator windings

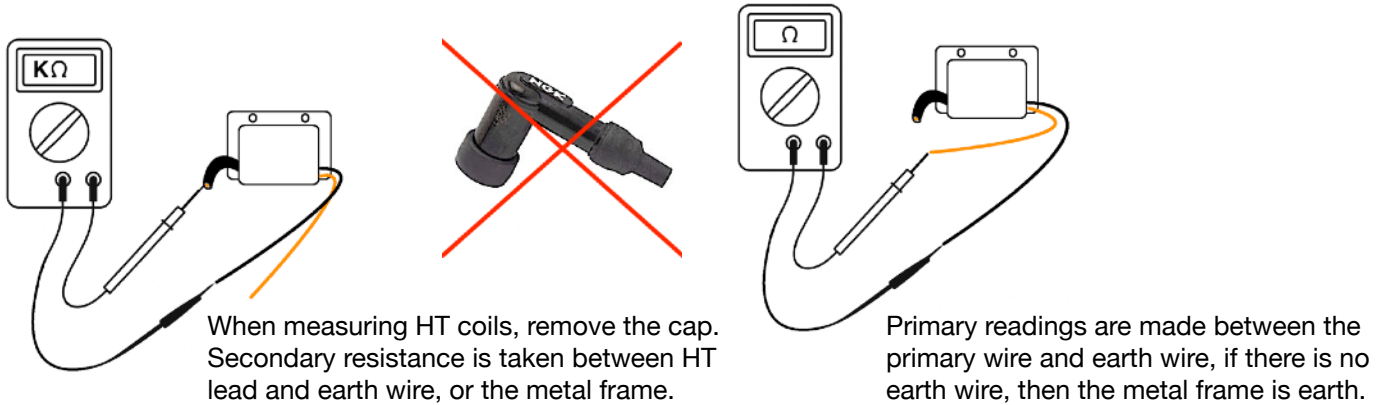
OEM HT coils have the resistance specified in the manual, the same temperature rule applies. Aftermarket ones may vary, there are factors that manufacturers balance differently which gives rise coils with slightly different resistances when new. Therefore in the case of HT coil resistance, sensible values are more important than exact ones, especially where after market parts have been fitted. Readings that are very different, no reading or one that is not steady are a cause for concern, for example a primary resistance of around 4-5 ohms shows that a battery and contact breaker ignition coil has been fitted by accident, this should be replaced with the CDI type.

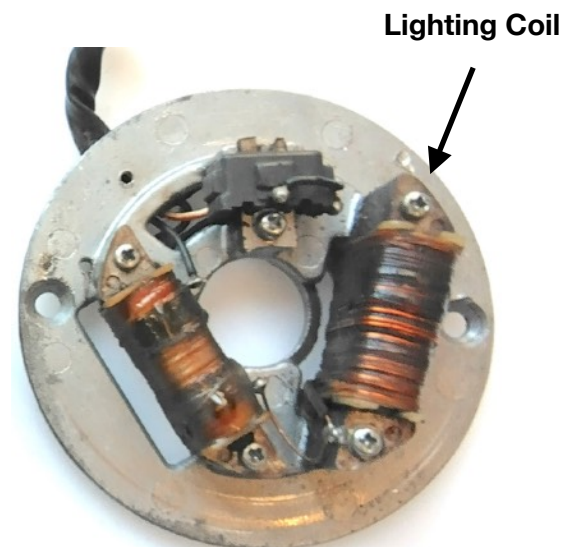
Check for: General condition, signs mechanical damage to the copper, discolouration due to overheating. The winding on the right has distinct areas that have darkened showing overheating. Look at the insulating pieces at each end of the copper, these form part of the mechanical support for the winding, if missing or damaged, the winding is no longer properly supported or sealed. Check also the copper is tight on the steel former, firmly hold it with your fingers and attempt to move it back and forth towards the mounting screws, also attempt to twist it. Any movement of copper on the former, even slight shows a failure.

On these bikes It is not unusual to find the lighting coil wiring has been cut and modified, sometimes resulting in a lot of damage to the winding itself. Modification in this area requires very high temperature materials and a great deal of experience to make a reliable connection.
