# Rex's Speed Shop

Guide: Rotax-1, 348, 504, 560 & 604 Engines  
ND CDI Ignition Troubleshooting Guide

## Introduction: Rotax Ignition System

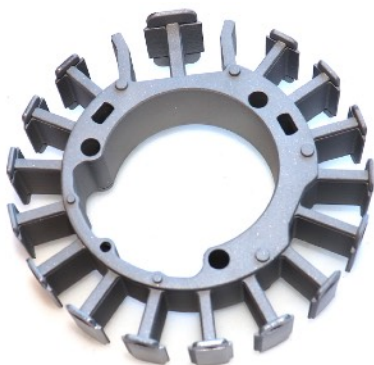
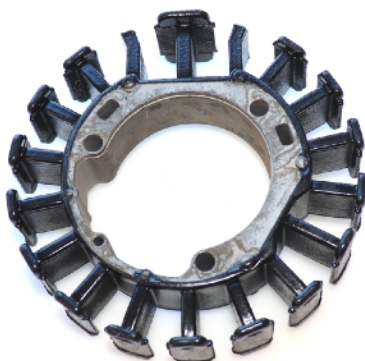
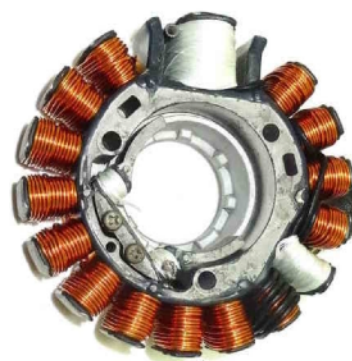
## A Rex's Rewind ~ Defining the process

Much of the equipment we deal with is now more than 30 years old and well beyond its intended design life. Age-degraded electrical insulation is one of the most common causes of stator failure.

First the stator is stripped of all copper and insulation material under controlled conditions so that its magnetic properties are not degraded. Replacing insulation before new winding wire is applied is an essential part of the rewinding process, not an optional extra. Careful replacement of the winding to exact OEM specification ensures maximum output and lifespan of the overhauled part.

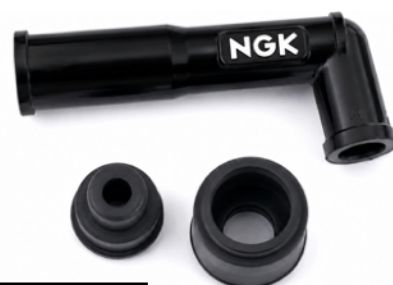
**XD05F:** Correct plug cap for Rotax engines. This system requires a 5KΩ resistor in the cap

The workshop manual describes the full test procedure if further information is required. The HT coil must be used with a  $5\ \text{K}\Omega$  spark plug cap, which must be removed while testing.

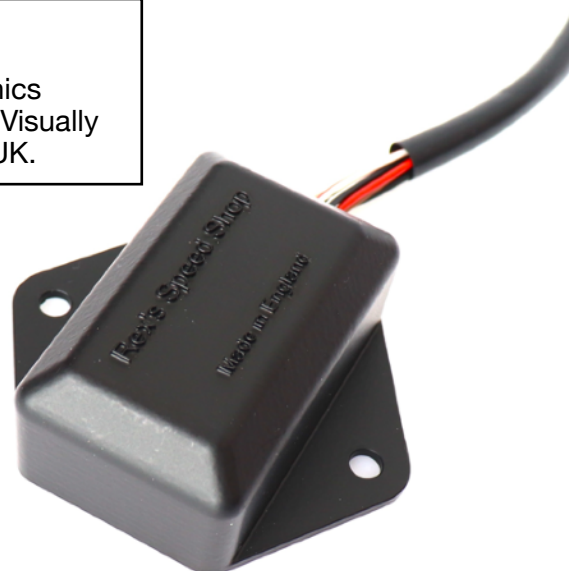
### Special Edition Amplifier unit.

Thoroughly tried and tested electronics mounted in a much improved case. Visually similar to the original unit. Made in UK.
