# Rex's Speed Shop

## Guide Y-2 XT500 G & H American Market Models

### CDi Electronic Ignition Troubleshooting Guide

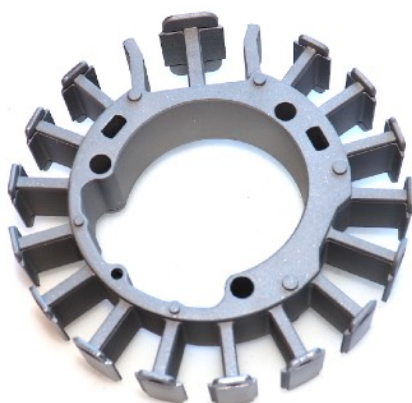
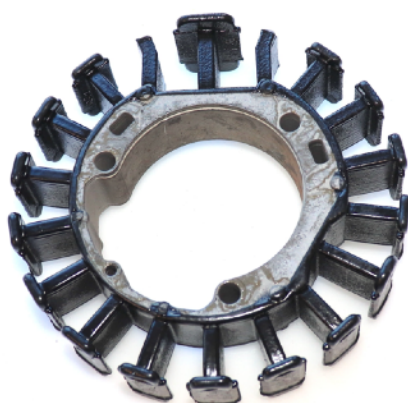
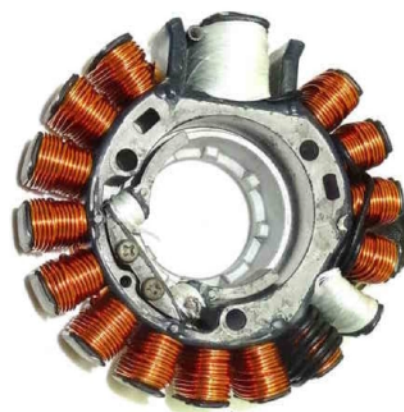
#### Rex's Rewinds (SR500 Stator Shown)

First the stator is stripped of all copper and insulation material under controlled conditions so that its magnetic properties are not degraded. Replacing insulation before new winding wire is applied is an essential part of the rewinding process, not an optional extra. Careful replacement of the winding to exact OEM specification ensures maximum output and lifespan of the overhauled part.

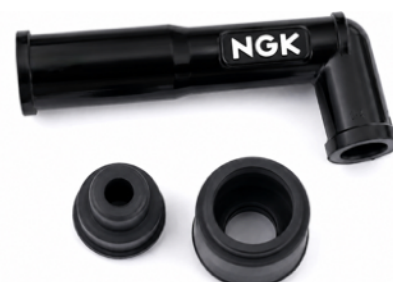
**XB05F:** Correct plug cap for SR & XT models. This system requires a 5KΩ resistor in the cap
