**Rex's Speed Shop**  
**Guide Y-3: CDi Ignition/Generator Trouble Shooting**  
**Yamaha DT360A, DT400B & C 1974-76**  
MX400B - External Flywheel Generator Only  
IT400C 1976, YZ400C 1976

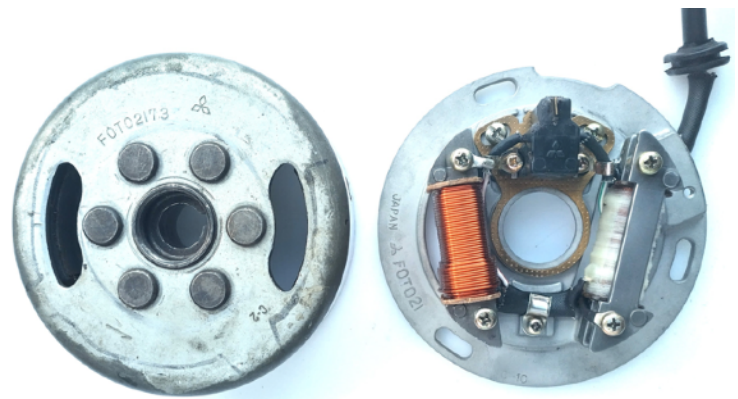
Unfortunately this first-generation design quickly developed a reputation for persistent running problems even during the motorcycle's original production life. The largest issue was the plastic-bodied trigger pick-up assembly (shown right), which became well known for causing misfiring, erratic running and persistent four-stroking faults. As a result, genuine replacement pick-ups are now virtually unobtainable. It should be remembered that any surviving "new old stock" components may themselves have originally been removed from motorcycles as faulty warranty parts decades ago, often placed in to the box the replacement came in.

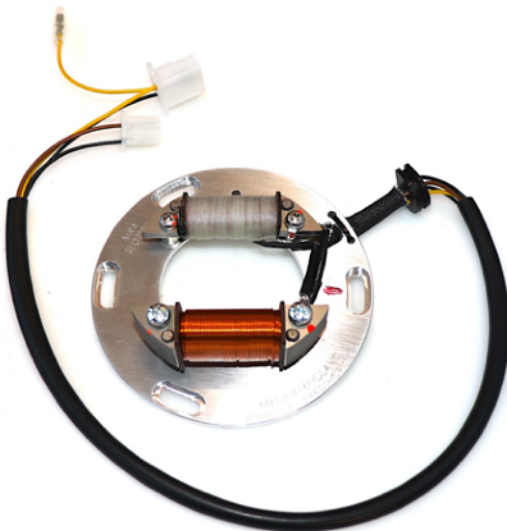
The RMK8-12V stator (left) replaces both ignition and up-grades to 12V electrics removing all the problems.

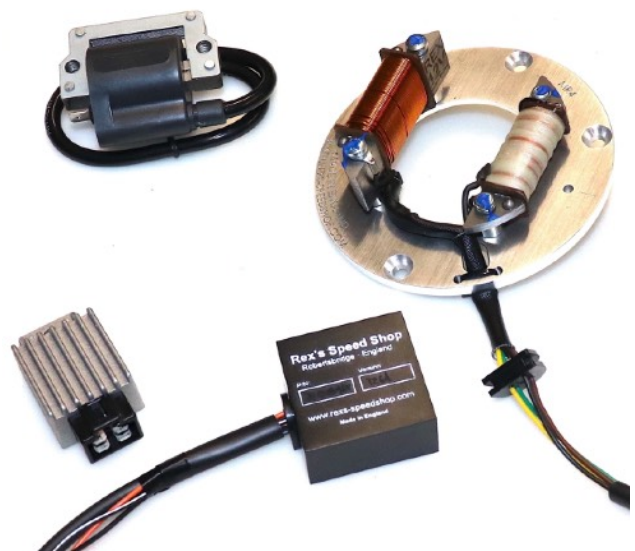
The **RMK8-12V Stator Kit**, a modern ignition & charging system up-grade.

- **Brand new ignition & 12V billet stator plate**
- **Fully regulated 12V AC lighting**
- **New HT Coil**
- **New electronic ignition - does away with the original pick-up.**
