Rex's Speed Shop

Guide Y-7: CDI Ignition Trouble Shooting

Yamaha DT175 (1978-79) ~ IT125 (1980-81) IT175 (1979-83)
& IT490 (1983-84) USA & Canada Models Using our DT2 CDI

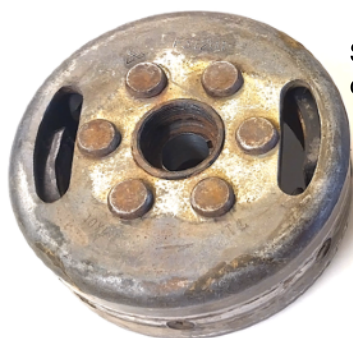
Two 'windows' in the flywheel

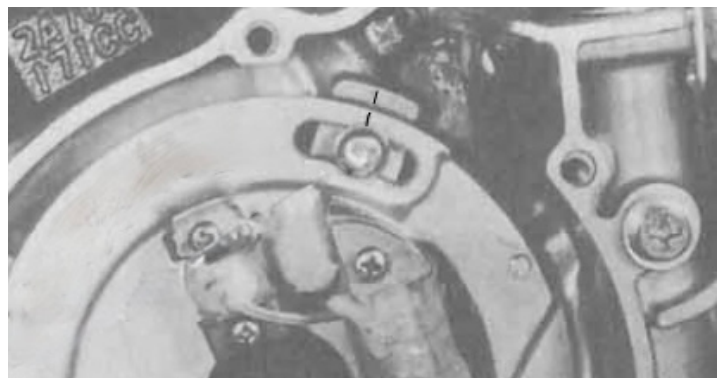
Ignition timing for these models is described in terms of static timing, using a DTI to set the piston position. To assist production-line setup, the factory added a small alignment mark to the stator and crankcase, shown below. These marks are not usually present on other CDi-equipped models of this age. They can also be used to align the flywheel timing marks with a strobe, allowing much more accurate ignition timing adjustment.

Set up marks used by the factory and described in the shop manual
