# Rex's Speed Shop

## CDi Ignition Trouble Shooting

Yamaha DT175 (1978-79) ~ IT125 (1980-81) IT175 (1979-83)  
& IT490 (1983-84) USA & Canada Models Using our DT2 CDI

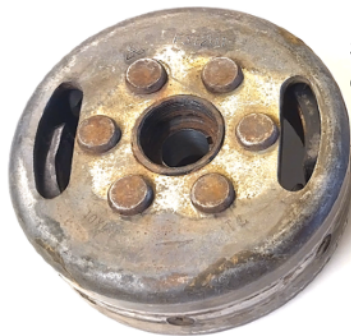
Two 'windows' in the flywheel

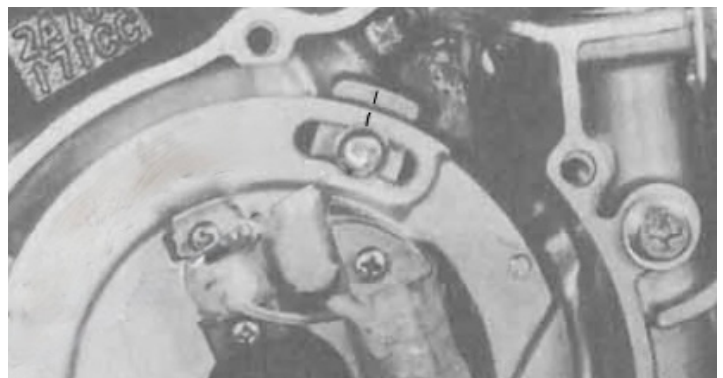
Ignition timing for these models is described in terms of static timing, using a DTI to set the piston position. To assist production-line setup, the factory added a small alignment mark to the stator and crankcase, shown below. These marks are not usually present on other CDi-equipped models of this age. They can also be used to align the flywheel timing marks with a strobe, allowing much more accurate ignition timing adjustment.

Set up marks used by the factory and described in the shop manual
