Rex's Speed Shop
Guide Y-6: CDI Ignition Generator Checks & Ignition Timing
 Yamaha DT125MX 1986-89, DT125MX 1991, DT125 1980-81
 DT175 1980-81

Guide Y-6: CDI Ignition Generator Checks & Ignition Timing

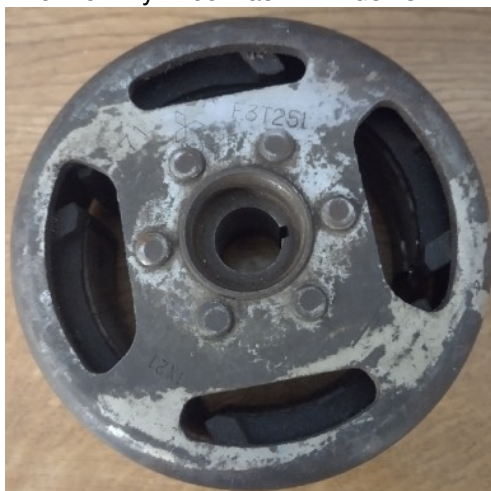
F3T251 Flywheel has 4 'windows'
