**Rex's Speed Shop**  
**CDi Ignition Generator Checks & Ignition Timing**  
 Yamaha DT125MX 1986-89, DT125MX 1991, DT125 1980-81  
 DT175 1980-81

**Identify the system:**

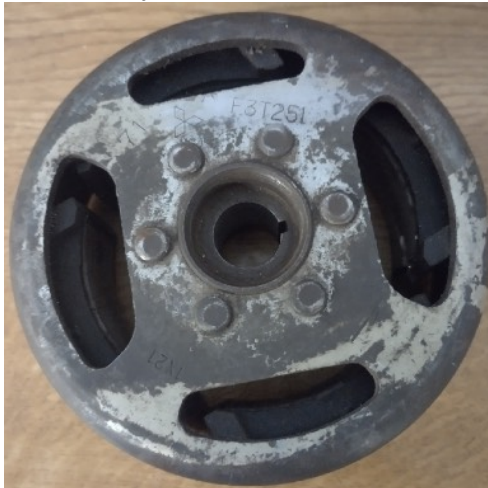
F3T251 Flywheel has 4 'windows'
