Rex's Speed Shop

Guide Y-8: CDi Ignition Generator Checks & Ignition Timing

Yamaha IT200 1984-86

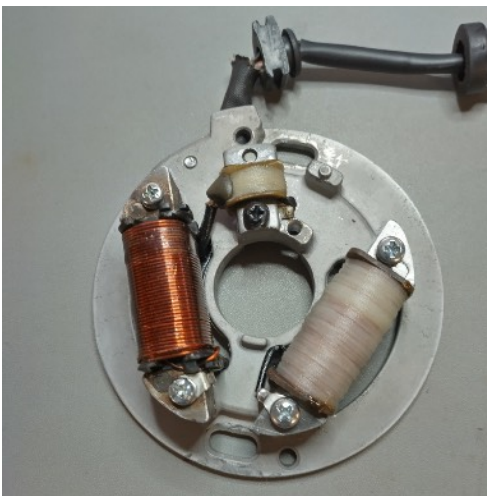
IT200 Stator:

Single source coil, mounted on the **right** of the pick-up.

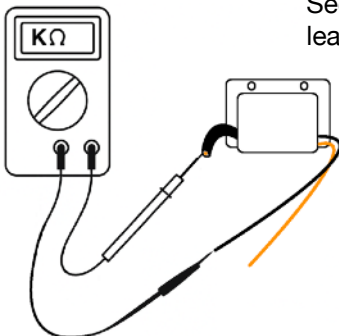
When measuring HT coils, remove the cap. Secondary resistance is taken between HT lead and earth wire, or the metal frame.

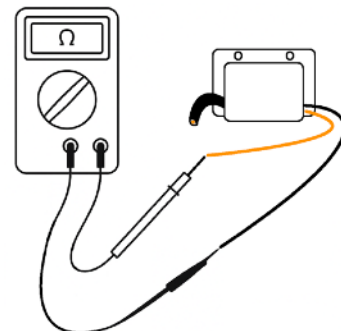
Primary readings are made between the primary wire and earth wire, if there is no earth wire, then the metal frame is earth.

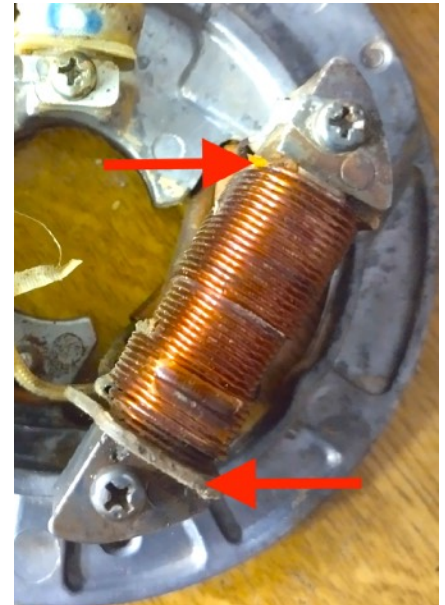
General condition, the winding on the right has an end piece missing, a common issue on older generators. The insulating end pieces must be intact at both ends of the winding as these prevent the copper from contacting the steel winding slot. They also form part of the mechanical support for the winding, if missing or damaged, the winding is no longer properly supported or sealed.

Check also the copper is tight on the steel former, firmly hold it with your fingers and attempt to move it back and forth towards the mounting screws, also attempt to twist it. Any movement of copper on the former, even slight shows a failure.

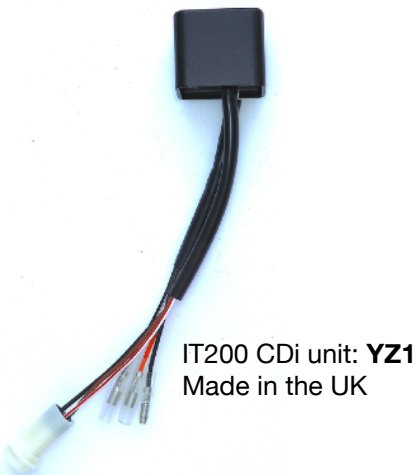
IT200 CDI unit: **YZ1**
Made in the UK

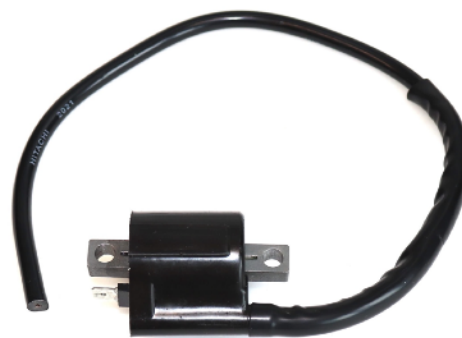
IT200 Replacement HT coil
HTC30-4
