Rex's Speed Shop
Guide Y-9 CDI Ignition & Generator Trouble Shooting
 Yamaha TY250 R&S1984 -1991 Air Cooled
 TY350
 With Mitsubishi CDI

CDi units are not testable by mechanics, so we focus on looking at areas that cause problems as the machine ages that can be tested easily. The generator on these models is very similar, and although it was supplied with and without lighting and differently weighted flywheels, essentially the ignition items are the same. The windings can usually be assessed with a careful visual inspection and basic multimeter tests. Remember, older than 20 years = older than intended life.

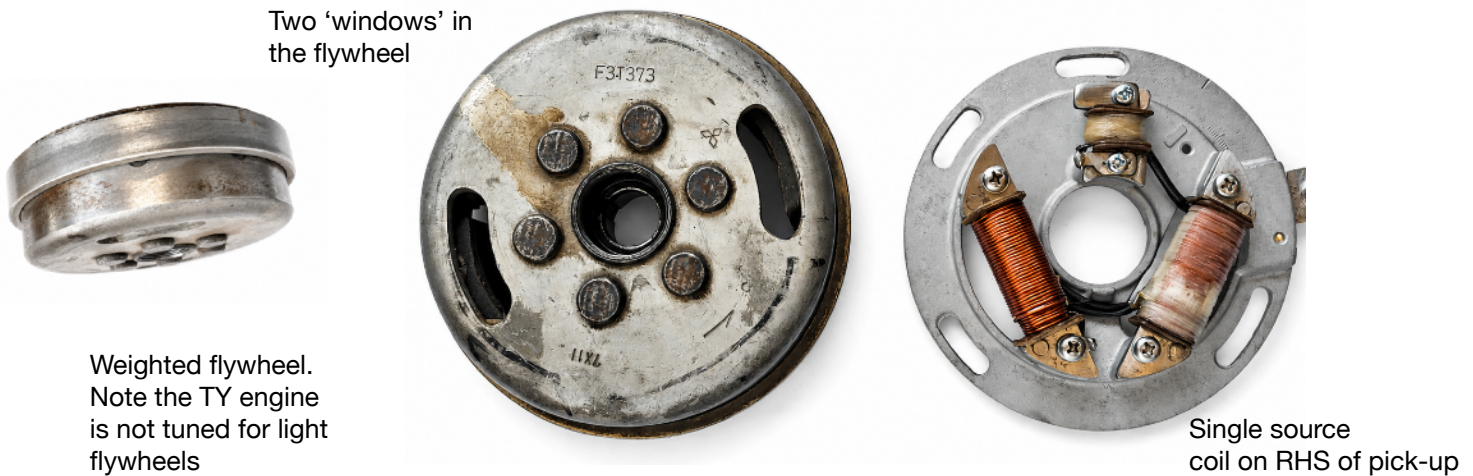
Weighted flywheel.
 Note the TY engine is not tuned for light flywheels

Single source coil on RHS of pick-up

Manufacturer	Mitsubishi	Test	Resistance at 20°C
FLYWHEEL	F3T373	White/red ~ Black	4Ω
OEM CDI P/N	53Y-85540-20	Brown ~ Black	240Ω
REX CDI P/N	TY2	HT Coil PRI / SEC	Original 1.0Ω / 5.9KΩ Replacement 0.6-1.8Ω ~5-8KΩ
IGN TIMING	5N9 2.6mm BTDC (20°BTDC) 38V 2.8mm BTDC (21°BTDC)	Static set up is shown, but engine timing marks align when checked with a strobe at 2,500RPM

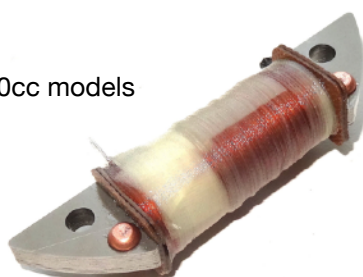
New 240 ohm source coil for TY250 & 3500cc models
P/N: SC8
 Made in England

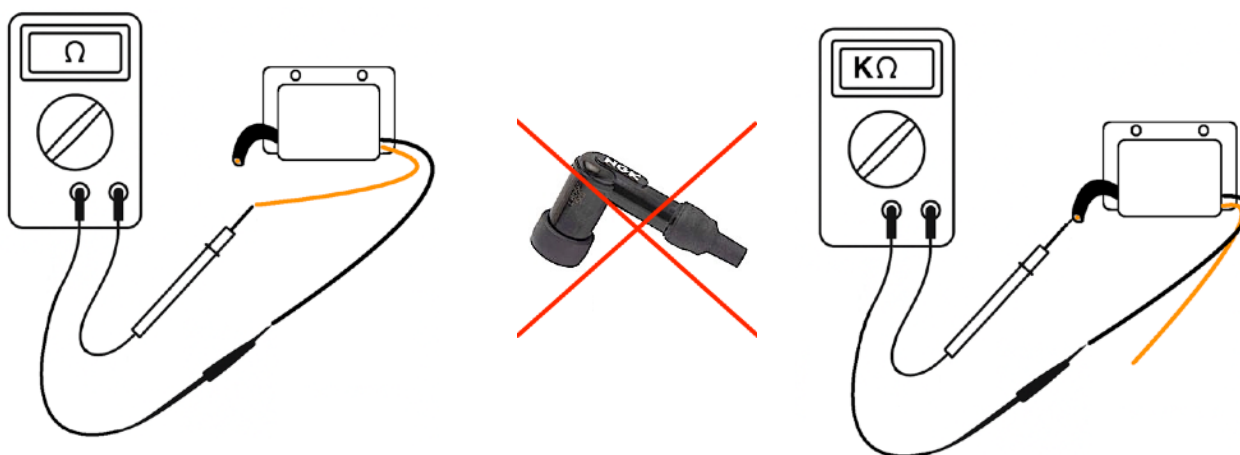
HT Coils

Original HT coils were generally 1.0 Ω /5.9K Ω . Aftermarket coils show some variation in resistance, so here we are looking for 'sensible' readings. HT coils are very heavily stressed and tend to simply stop working, although occasionally they can cause bad running at high RPM before ceasing to function. Problems may also occur with the HT lead which in many cases is not replaceable. We remind you that parts which are clearly manufactured with a low price being the key specification often let you down when it matters most.

When measuring the HT coil, always remove the HT Cap.

Primary: measure between primary wires or if there is only one wire, that and the coil frame.

Secondary: measure between HT lead and earth wire or coil frame if there is only one primary wire.

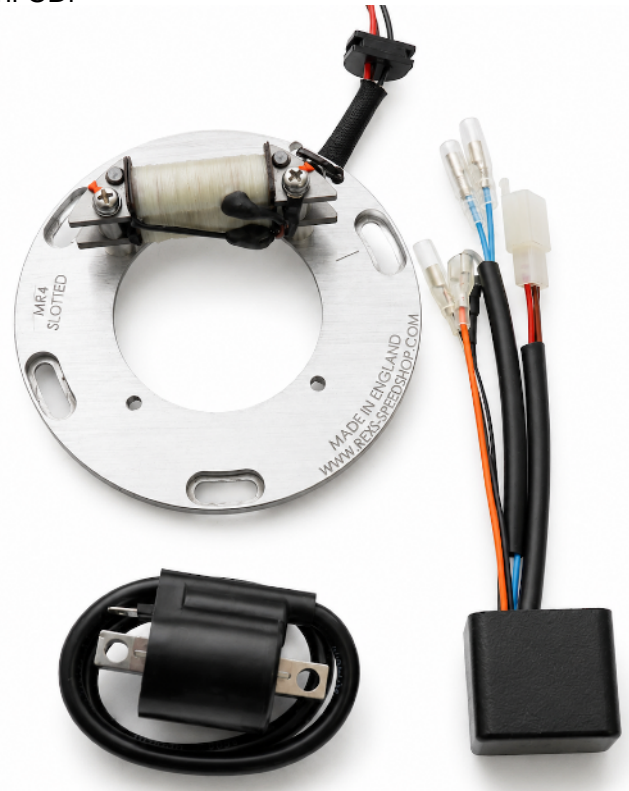
RMK1, 3 & 5 Stator Kits

Both our **Clubman** and **Pro** ignition systems feature our unique **Dual Power™** stator assembly.

Unlike systems that rely on a single source winding, the **Dual Power™** design delivers substantially more electrical energy to the CDI unit without causing peaky engine performance. The result is a less electrical stress on each winding, stronger spark, and steady consistent performance, all day.

- New stator
- New HT coil
- New CDI unit

Available for 175, 250 & 350cc machines
