**Rex's Speed Shop**  
**CDi Ignition/Generator Trouble Shooting Guide 4**  
Yamaha DT400D&E 1977-78  
IT250 1977-80  
IT400 1977

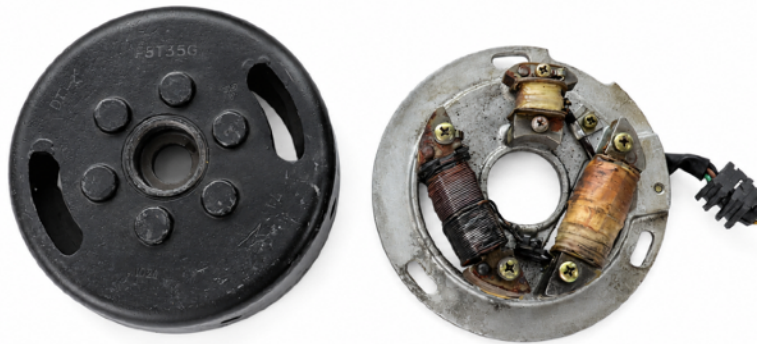
The 1977-8 (D&E model) generator represents a marked improvement in both running and lighting. The black plastic pick-up and fixed timing was replaced by an all metal pick-up which is easily identified by its thick, 'chunky' appearance. This system gives a few degrees of ignition advance, with full advance occurring at 4,000 RPM. The source coil appears similar to the B&C model, but has a revised winding resistance. IT models used a very similar generator up until 1980, with reduced lighting output. A point to be aware of is that the DT shop manual contains misprints, quoting the points magneto values for the CDI windings.

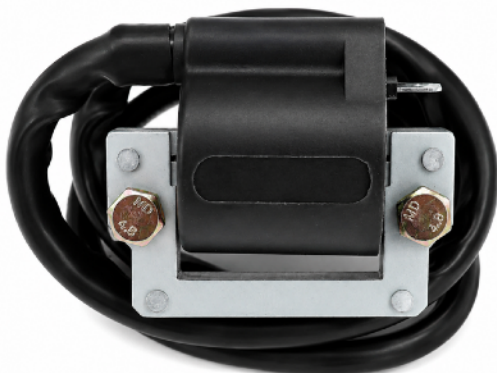
HT Ignition Coils for DT Models
