# Rex's Speed Shop

## Guide H-2: Honda CB400, CB450, CM400, CM450 Hitachi TIA01-20 CDI Ignition System Trouble Shooting Guide

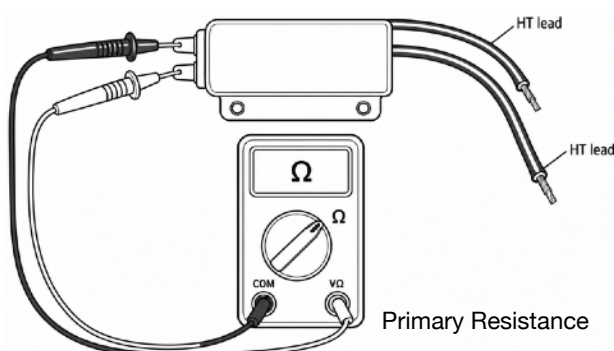
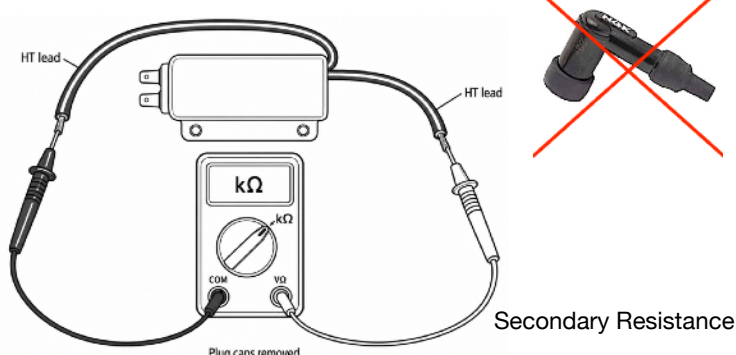
The workshop manual describes only a performance test for the ignition coil, requiring another piece of test equipment, but we have located resistance specifications in Honda's technical data. Always remove both HT plug caps before testing. Set your multimeter to k $\Omega$  (kilo-ohms) for the secondary winding and  $\Omega$  (ohms) for the primary. At 20°C, an original Honda coil should measure approximately 0.5  $\Omega$  primary and 8 k $\Omega$  secondary.

Unlike the CDI generator windings, HT ignition coils are not precision components, so aftermarket coils may give slightly different readings. Both readings should be steady. No reading or a fluctuating reading, once you have confirmed good probe contact, indicates a fault. The primary resistance must be very low. Reject coils measuring around 4 to 5 $\Omega$ : these are unsuitable for this CDI system, although they are sometimes incorrectly sold for it.

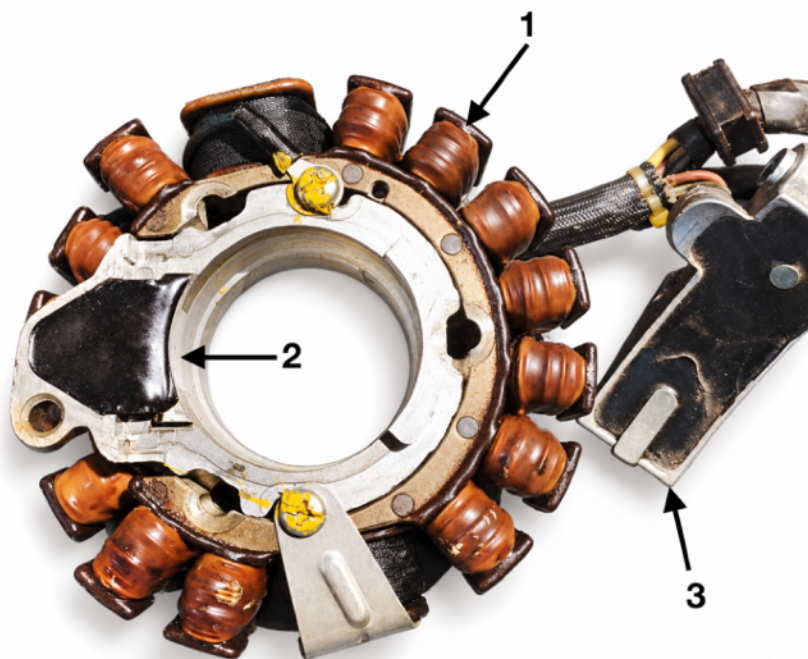
### CB400/450 Hitachi Ignition: Stator and Trigger Assemblies (Manual Transmission)

The complete Hitachi stator comprises three main assemblies: (1) the main stator frame, which carries the alternator and ignition source windings; (2) the high-speed trigger assembly, (3) low speed & advance limiter assembly.

1. Stator frame with AC charging and CDI source windings; The top, black coil is the low speed source. The high speed source is under the metal shroud opposite. The yellow paint on the screws shows us that this is the later version with full power lighting coils.
2. High speed trigger, this begins to work over 2,500RPM and causes the CDi to advance its spark. It has a few degrees of physical adjustment within the stator.
3. Low speed trigger & advance limiter. This dual function unit has two windings inside it that give the start up timing plus signals the CDi unit to prevent any further ignition advance at high engine speed.

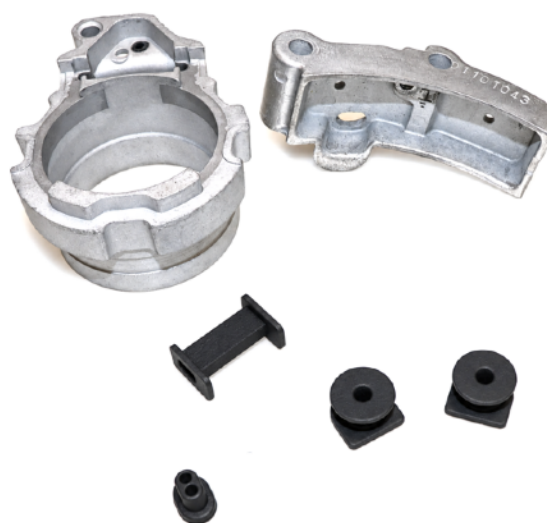
Hitachi TIA01-20 high and low-speed trigger assemblies stripped for rebuilding. At Rex's, we maintain the precise tolerances needed for consistent, reliable operation. New internal components and our own electronics are designed to reproduce the original system's performance.

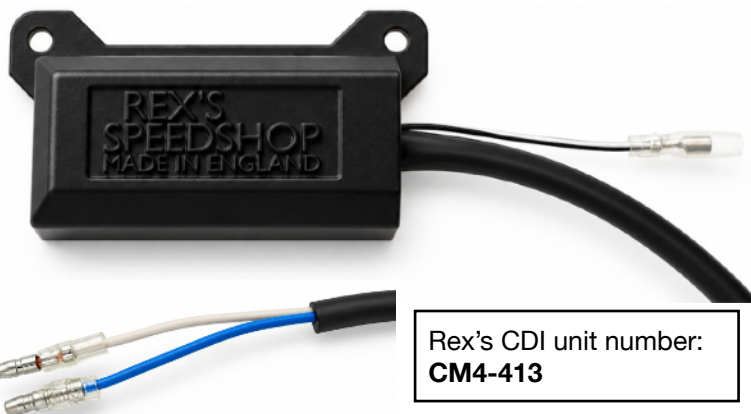
Rex's CDI unit number:  
**CM4-413**

Our replacement CDI unit for these models comes in two options, to match the white and blue pair. P/N CM4-413 is for early T models with individual terminals, while CM4-MC9 replaces all later versions using a 2-way push in connector.
